# The Reliability and Effectiveness of a Radar-Based Animal Detection System

<sup>1</sup> Western Transportation Institute - Montana State University

September 2017

INE/CESTiCC 17.14

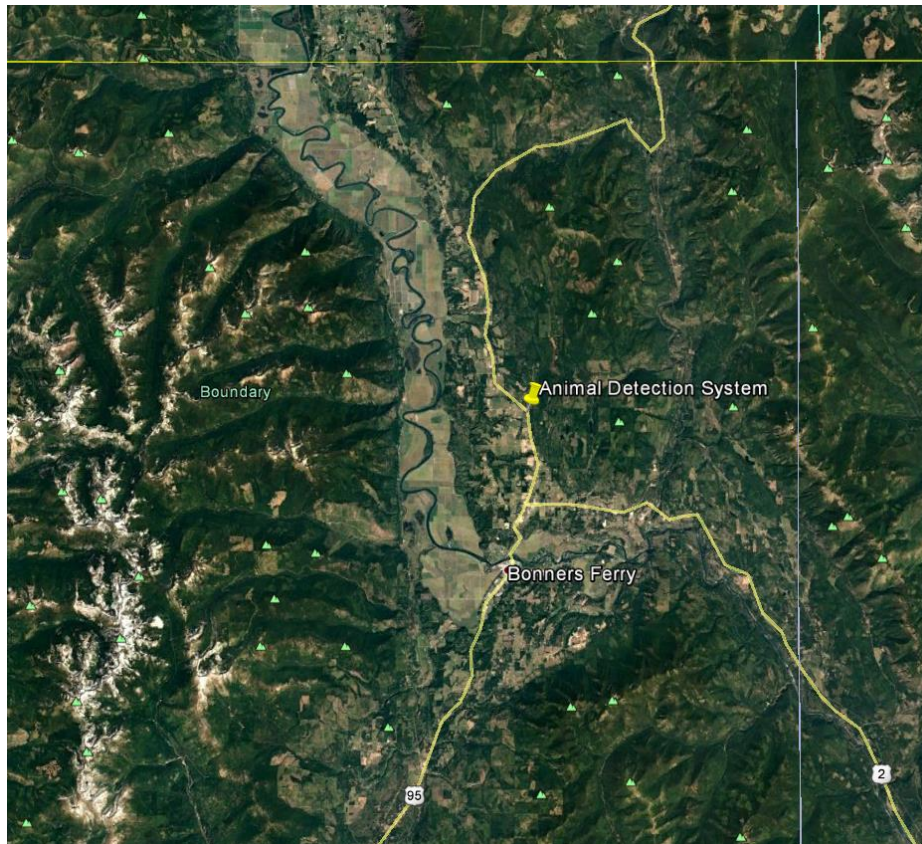
The animal detection system was located along U.S. Hwy 95 (mile reference post 514.49), about 4.1 mile (6.6 km) north of the junction with U.S. Hwy 2 north of Bonners Ferry, Idaho (Figure 2). The system was installed at this location in April 2014. The system was originally powered through a gas generator. Because of limited operation budget, the generator sometimes ran out of gas, and at other times there was no budget available to purchase gas. The generator needed to be filled with gas about once per month (Pers. Com. Brice Sloan, Sloan Security Technologies). Therefore, the system was intermittently in operation until July 2015, when it was connected to the electric grid. In early September 2015, the radar malfunctioned. A new radar was installed on 2 October 2015, and since then the system has been in continuous operation. Reliability and effectiveness data were only collected after these modifications and improvements. The manufacturer of the system (i.e., Brice Sloan, Sloan Security Technologies) continuously monitored the functionality of the system during the research period.

**Figure 2. The Location of the Animal Detection System.  
Along U.S. Hwy 95, North of Bonners Ferry, Boundary County, Idaho.**

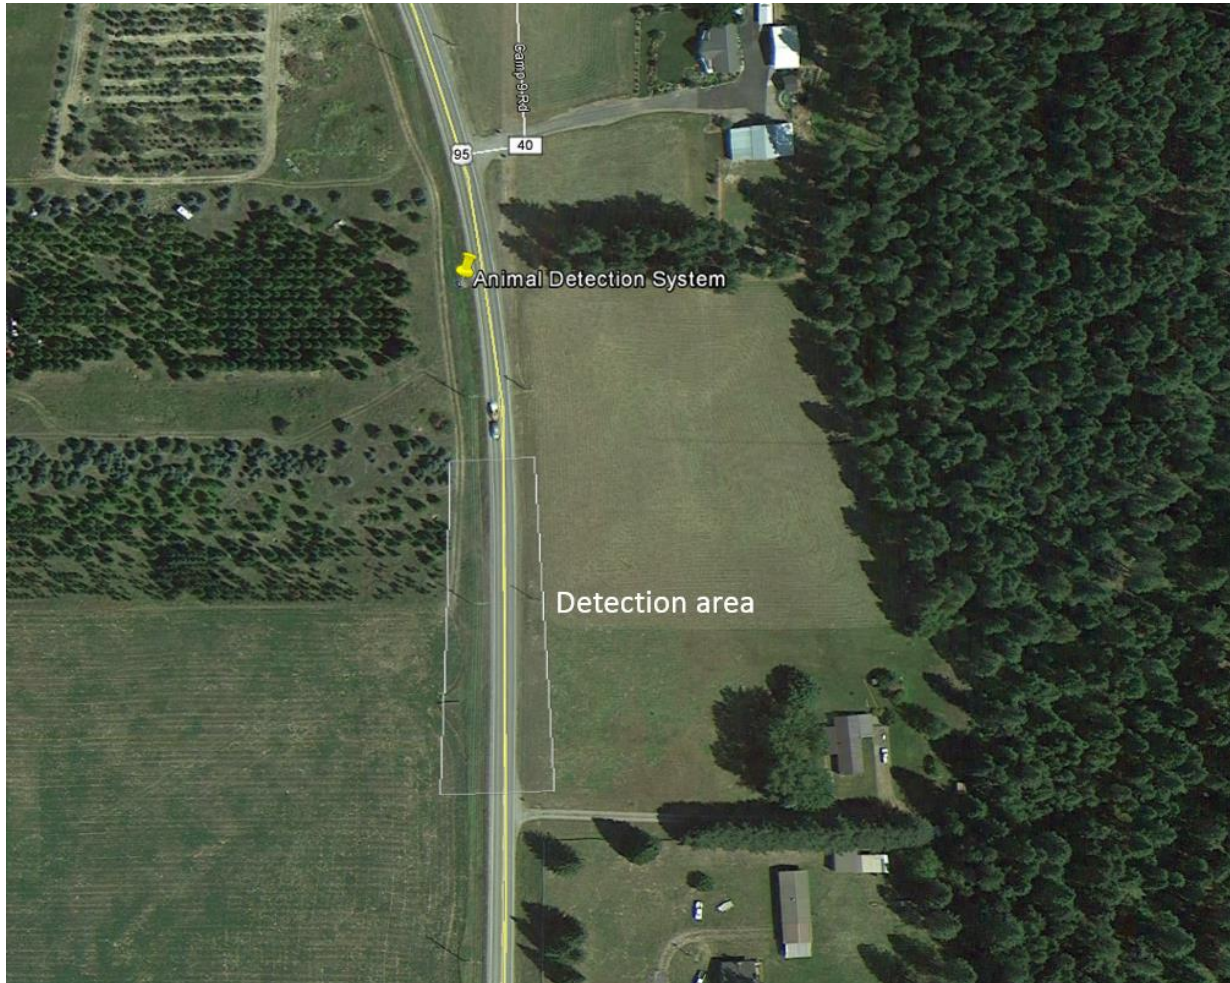
The system used a Doppler radar to detect large mammals along a 371 ft (113 m) long road section (Figure 3). The detection area was between 22 and 37 m wide and included the paved road and a zone adjacent to the paved road. However, the Doppler radar can be programmed to detect large mammals over much longer distances (about 1312 ft (400 m); Pers. Com. Brice Sloan, Sloan Security Technologies).

**Figure 3. The Location of the Doppler Radar System and the Detection Area.**

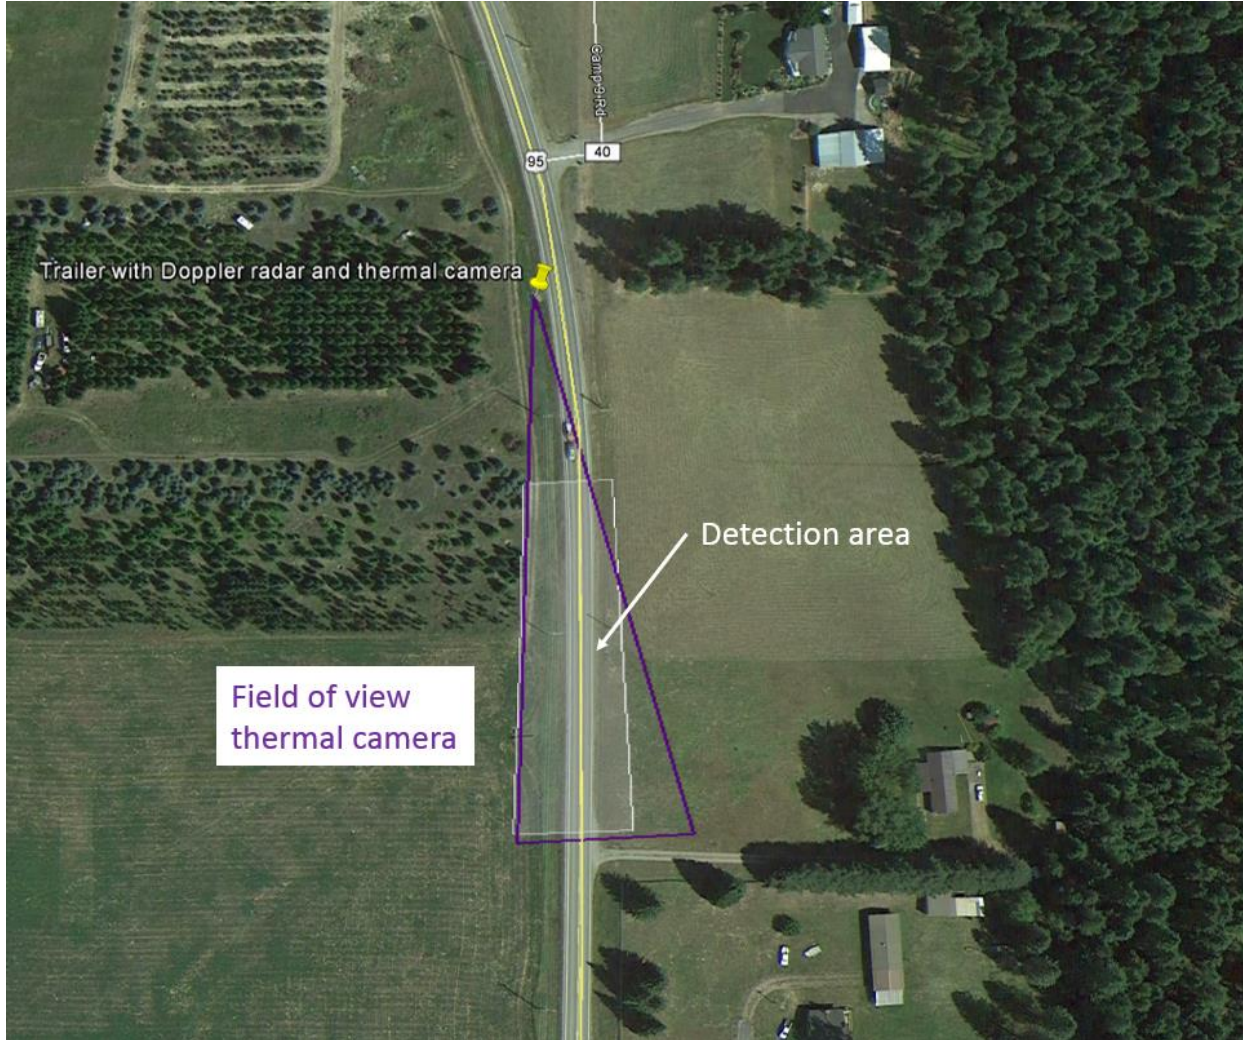
To evaluate the reliability of the radar in detecting large mammals, a thermal video camera was used to monitor wildlife in and around the detection area (Figure 5). Note the two small areas that were part of the detection area that were not covered by the thermal video camera (a narrow strip west of the highway and a small area in the northwest corner of the detection area (Figure 5). Every detection by the system was associated with a thermal image (1 image every 3 seconds) when the radar was detecting an object that matched the “large mammal” profile (Pers. Comm. Brice Sloan, Sloan Security Technologies, Inc.). The images of the thermal camera were continuously recorded and temporarily saved. When a detection occurred, the images were saved starting 3 seconds before the detection and ending 3 seconds after the detection. The video images had a date and time stamp, and also showed whether the Doppler radar detected an object that was presumably a “large mammal” (Figure 6). This

Note: Detection area delineated by the white line, thermal camera view delineated by the purple line.

**Figure 5. The Detection Area of the Doppler Radar and the Thermal Video Camera.**

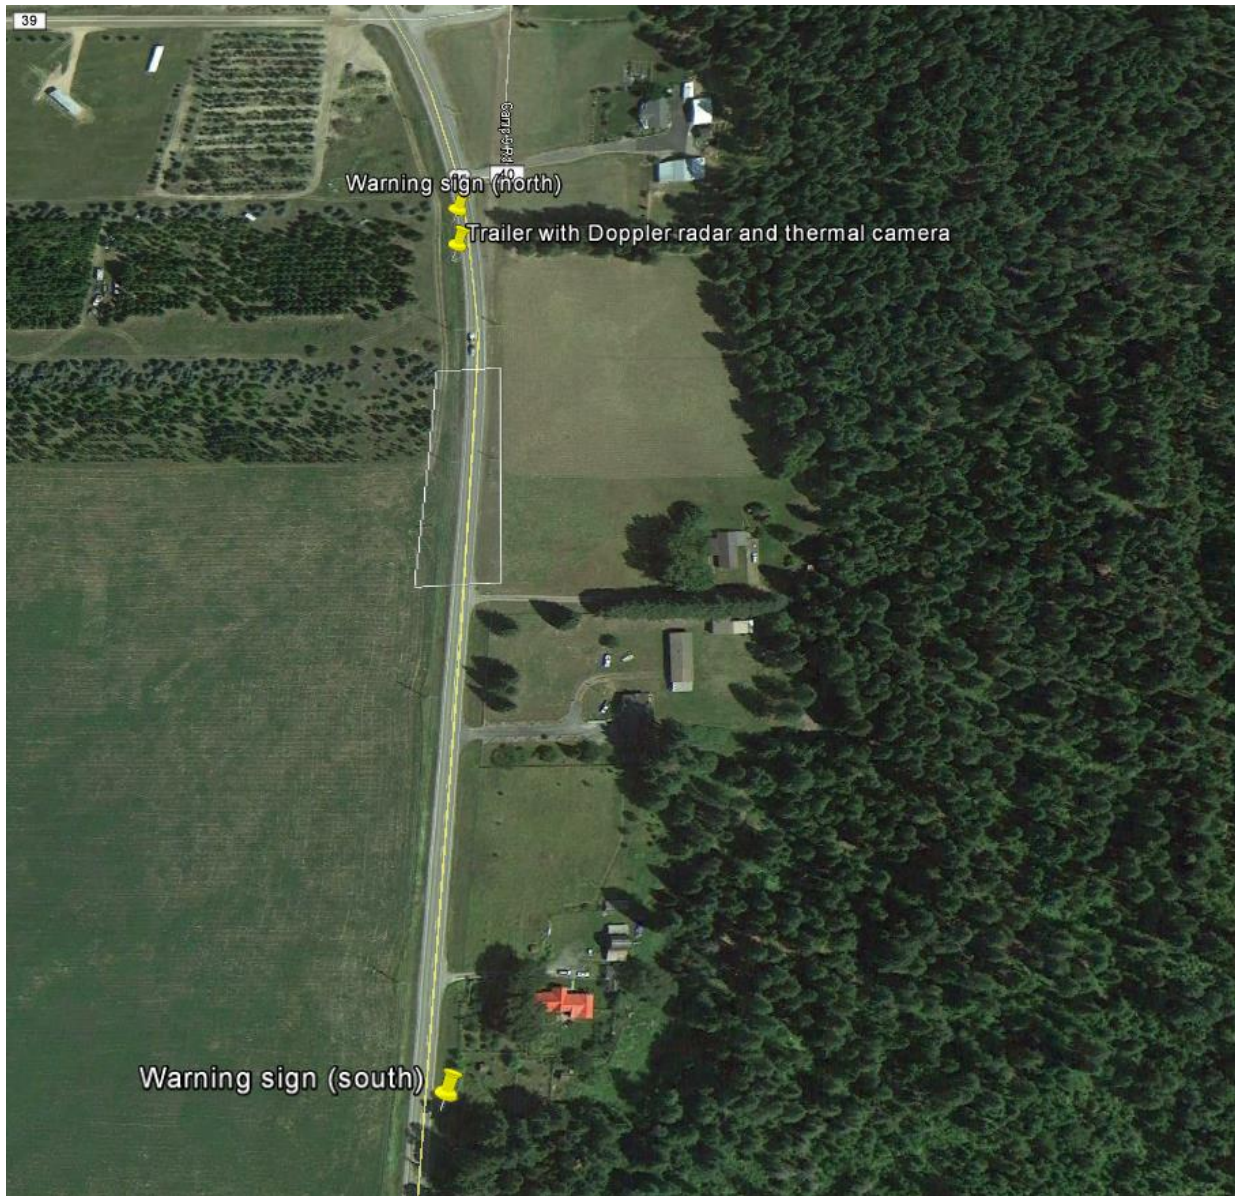
When the system detected a “large animal”, warning signs were activated. There were two warning signs: one was located 285 ft (87 m) north of the detection area (northern edge, mile reference post 514.45) for sound bound traffic, and one was located 735 ft (224 m) south of the detection area (southern edge, mile reference post 514.38) (Figures 7, 8) for north bound traffic.

Note: The detection area covered by the Doppler radar is delineated by the white line.

**Figure 7. The Detection Area and the Location of the Two Warning Signs.**

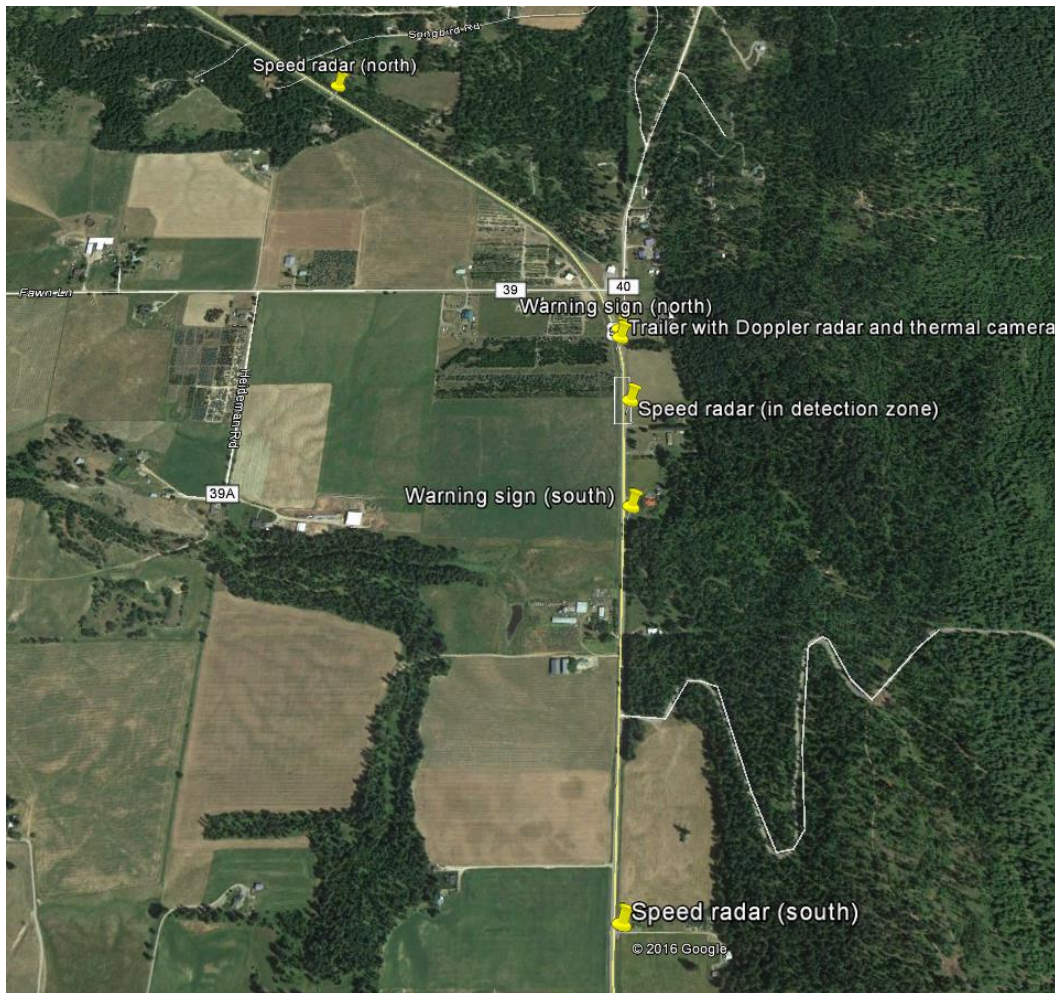
Three speed radars were installed to record the speed of individual vehicles. The speed radars were installed 0.62 mile (997 m) north of the northern warning sign, inside the detection area, and 0.51 mile (814 m) south of the southern warning sign (Figure 11). The three speed radars recorded the speed of individual vehicles and distinguished between the northbound and southbound lanes. The northern and southern speed radars measured the speed of vehicles before and after the warning signs and detection zone. The distance between these two radars and the warning signs was at least 0.5 mile (800 m). This distance was far enough to assume that the warning signs did not influence the speed of the approaching vehicles at the northern and southern speed radars. It is also likely that vehicles just passing the detection area and associated warning signs would have been able to regain normal operating speed. The distance between the southern warning sign and the central speed radar in the detection zone was 804 ft (245 m). The distance between the northern warning sign and the central speed radar in the detection zone was 590 ft (180 m).

Note: Also shown are the warning signs and the detection zone (delineated by the white line).

**Figure 11. The Location of the Northern, Central, and Southern Radar.**

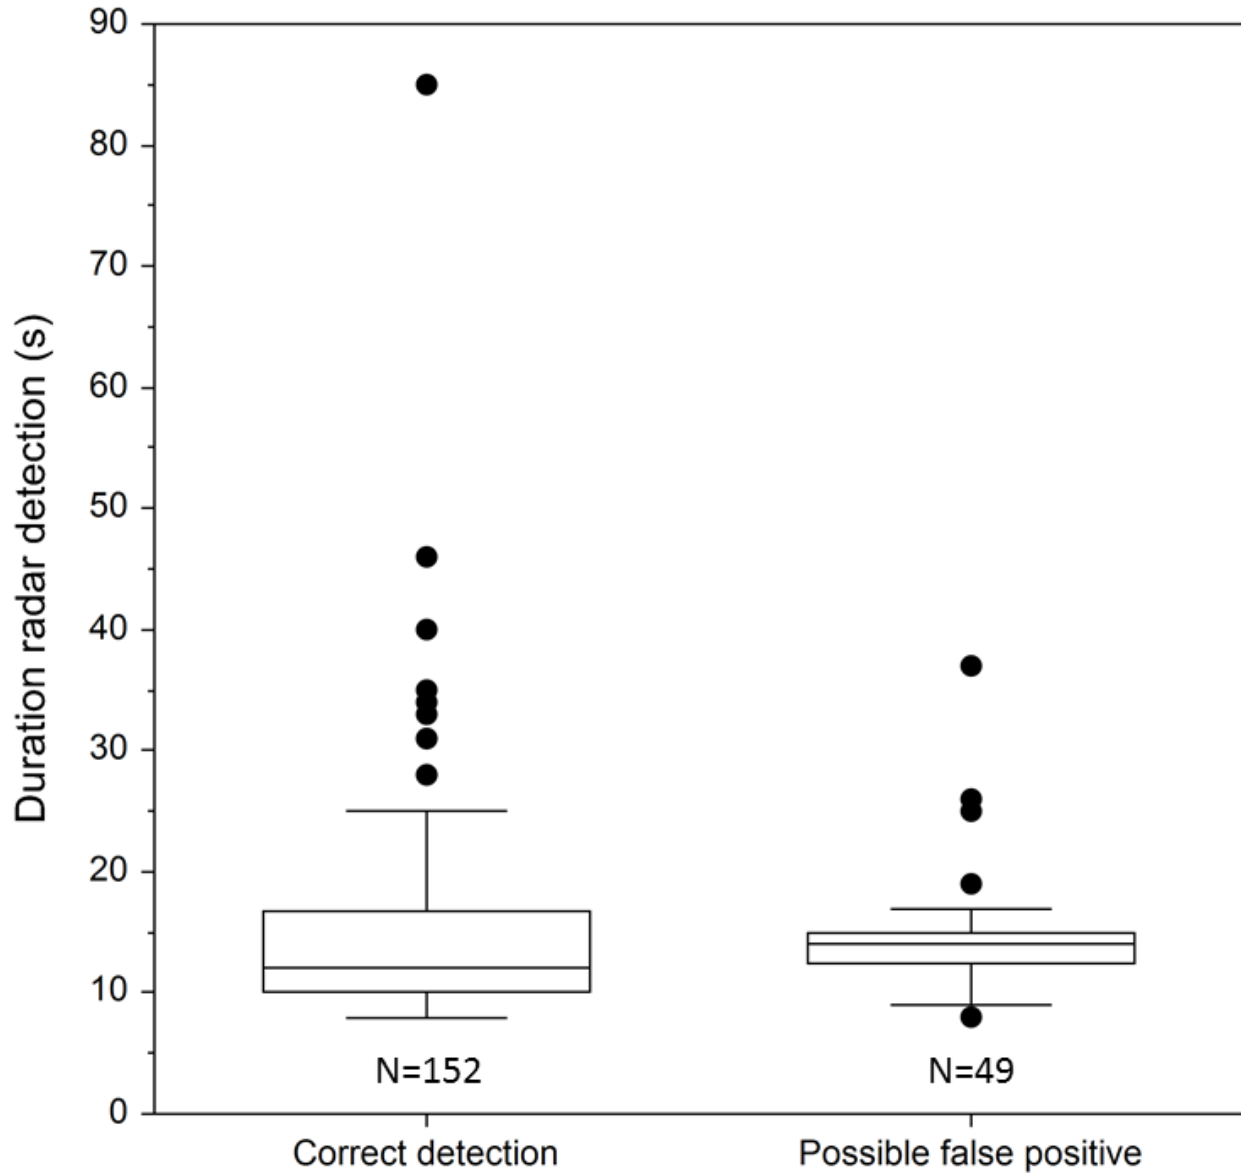
The average radar detection lasted 14.85 seconds (SD = 7.75, N = 201). There was no significant difference between the duration of the radar detections for correct detections and possible false positives (Mann-Whitney U-test, Z-value = 1.270, P = 0.204; Figure 12).

Note: The data relate to correct detections and possible false positives. Box: Middle 50 percent of the data (25–75 quartile); Horizontal line: Median; Whisker boundaries: 1.5 times inter-quartile range; outliers: Over 1.5 times inter-quartile range.

**Figure 12. The Duration of the Radar Detections.**

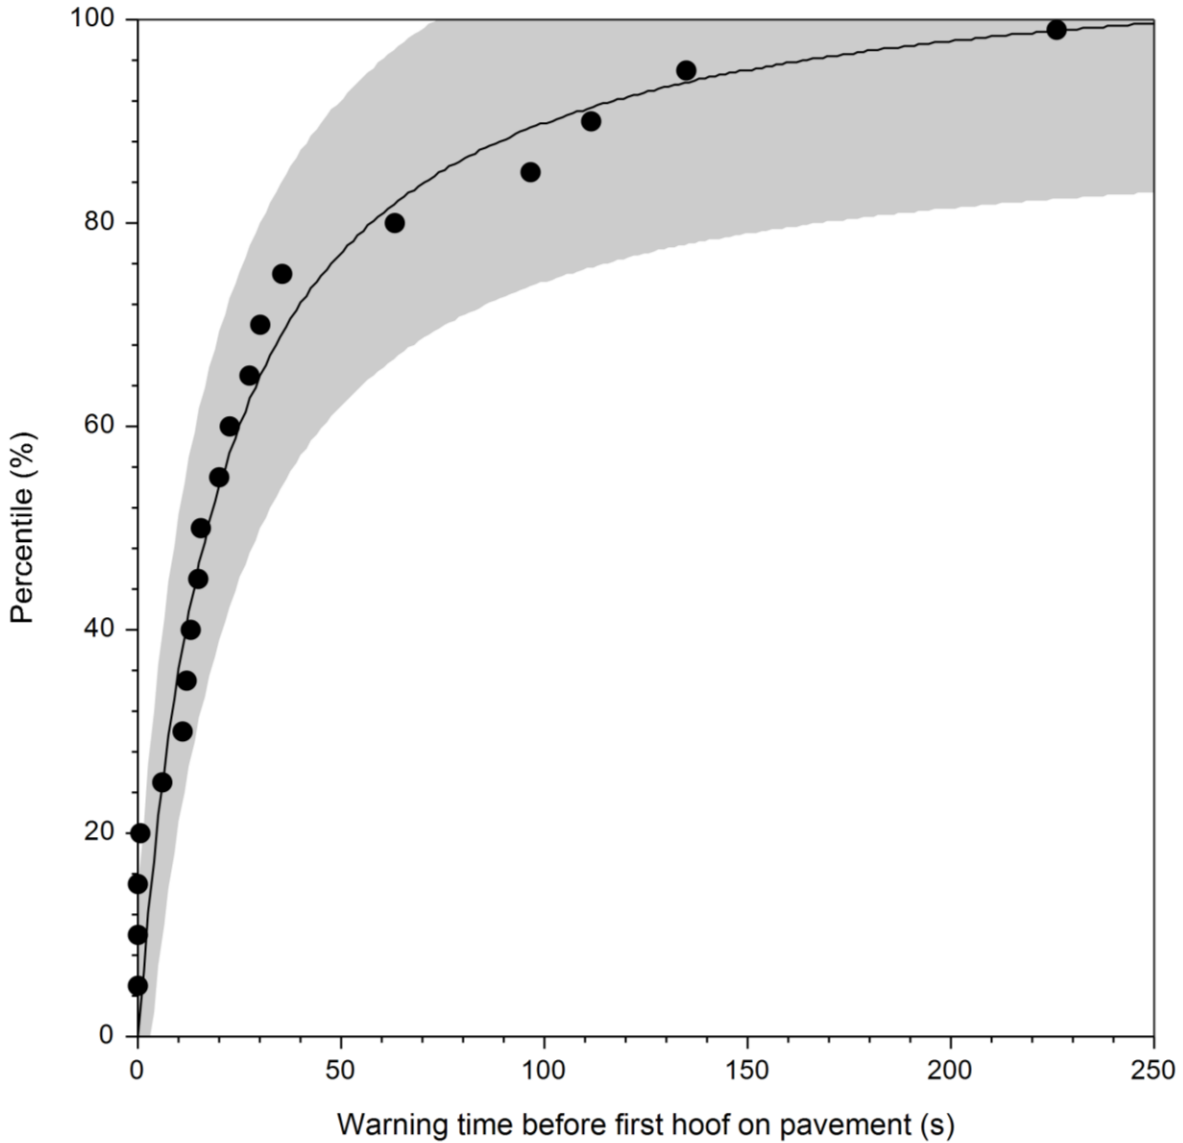
Note:  $\text{Percentile} = 107.56482 * \text{Warning\_Time} / (19.76350 + \text{Warning\_Time})$ ,  $R^2 = 0.94844$ . The shaded area adjacent to the curve represents the 95 percent confidence interval.

**Figure 17. The Percentile of the Warning Time before Deer Set First Hoof on the Pavement.**

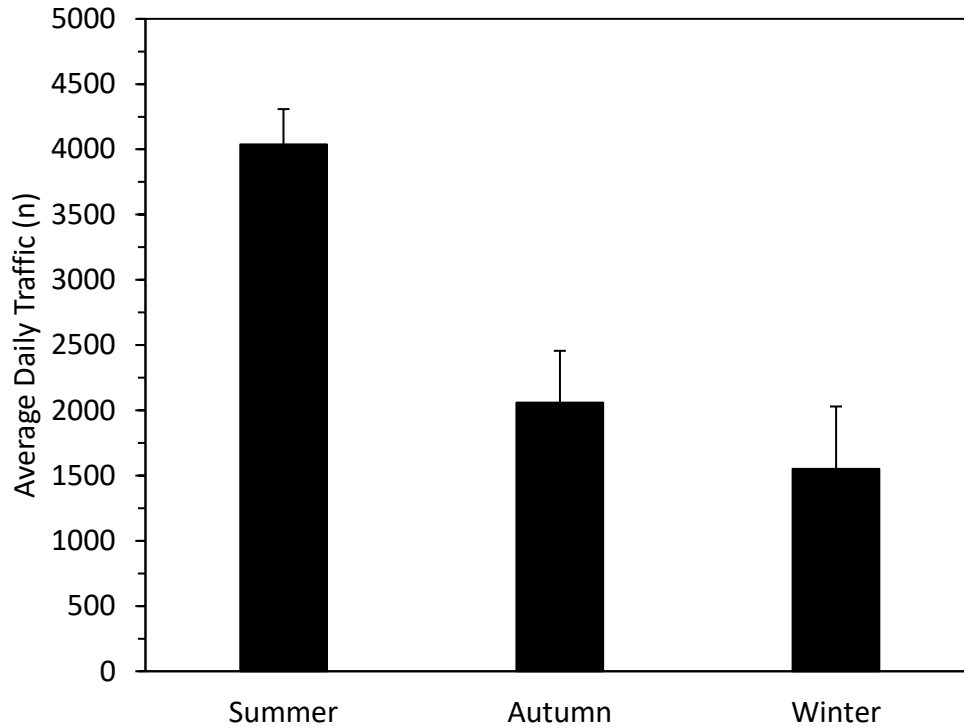
The speed radars also measured traffic volume. Traffic volume was much higher in summer (n=4,039) than in autumn (n=2,059) and winter (n=1,551) (Figure 19).

Note: The data relate to the number of vehicles per day for both travel directions combined (and standard deviation) for the ten consecutive speed trial days in the three seasons at the central radar.

**Figure 19. Average Daily Traffic for the Three Seasons.**

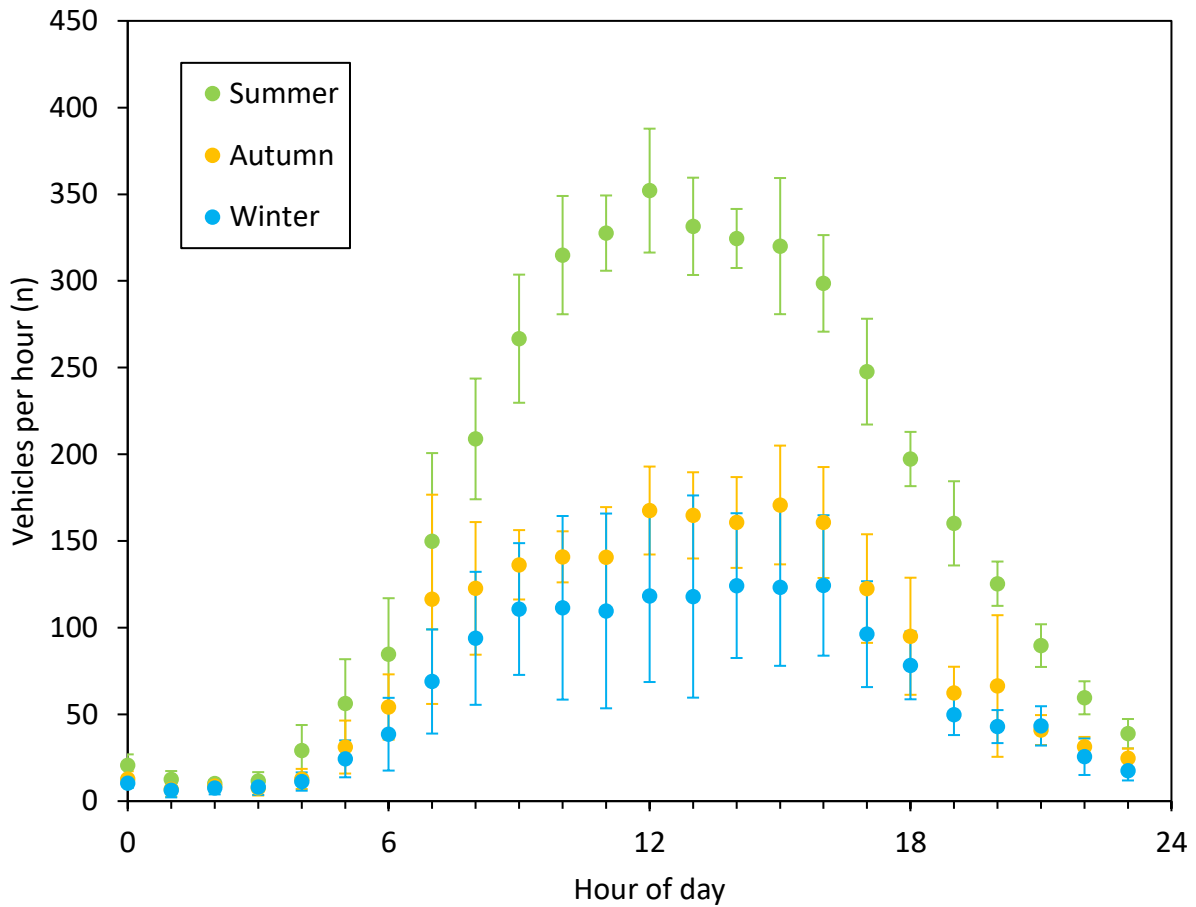
Traffic volume was highest between 9:00 and 17:00 (between 9 a.m. and 5 p.m.), with around 100 to 350 vehicles per hour (Figure 20). Traffic volume was lowest between 1:00 and 4:00 (between 1 a.m. and 4 a.m.) with 6 to 13 vehicles per hour.

Note: The data relate to ten consecutive speed trial days at the central radar. 6 = Between 6 and 7 A.M., etc.).

**Figure 20. Average Traffic Volume per Hour and Associated Standard Deviation in the Three Seasons.**

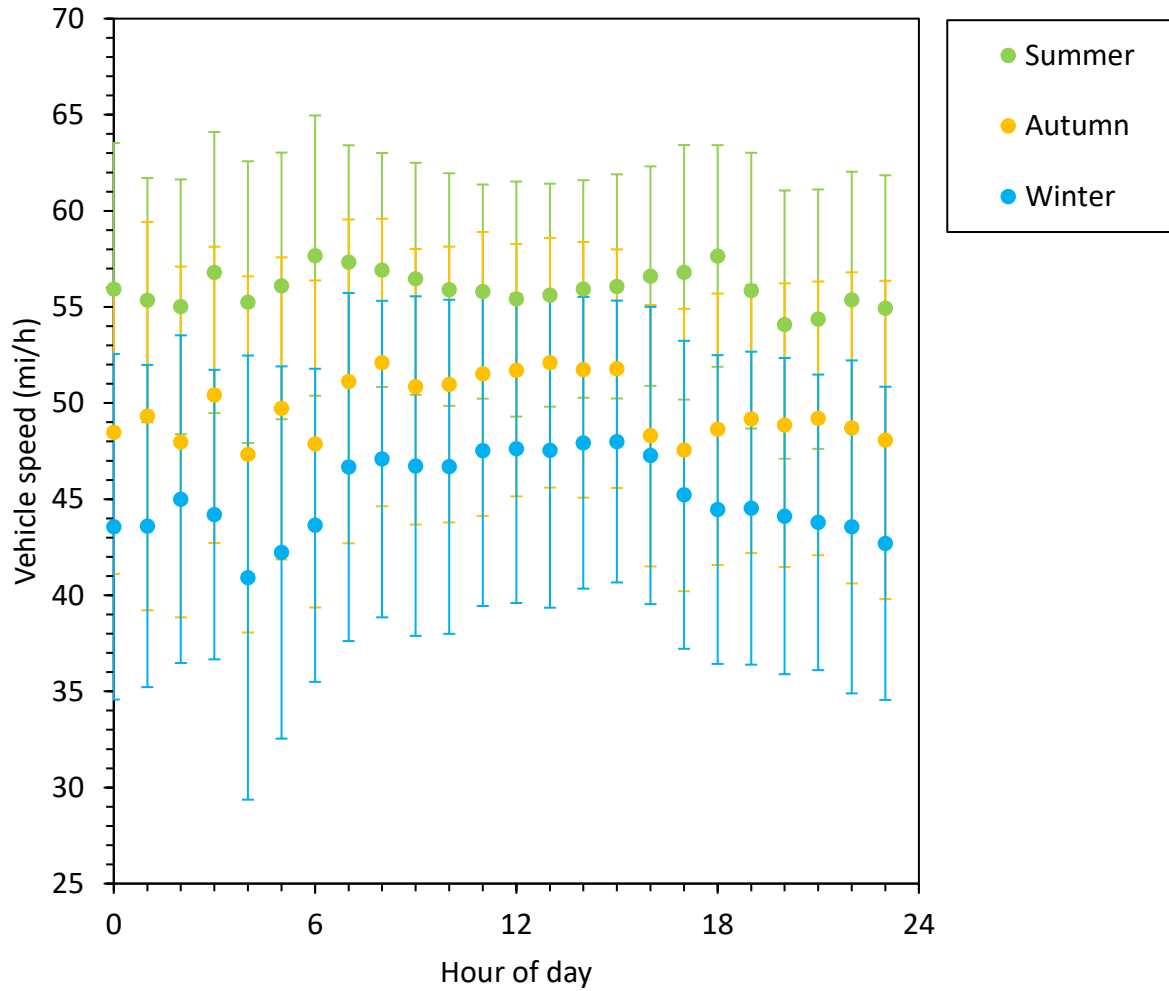
Vehicle speed was highest in summer and lowest in winter (Figure 21). In general, vehicle speed was highest during the day and lowest during the night.

Note: The data relate to the ten consecutive speed trial days in the three seasons. 6 = Between 6 and 7 A.M., etc.).

**Figure 21. Average Vehicle Speed per Hour and Associated Standard Deviation for the Three Seasons.**

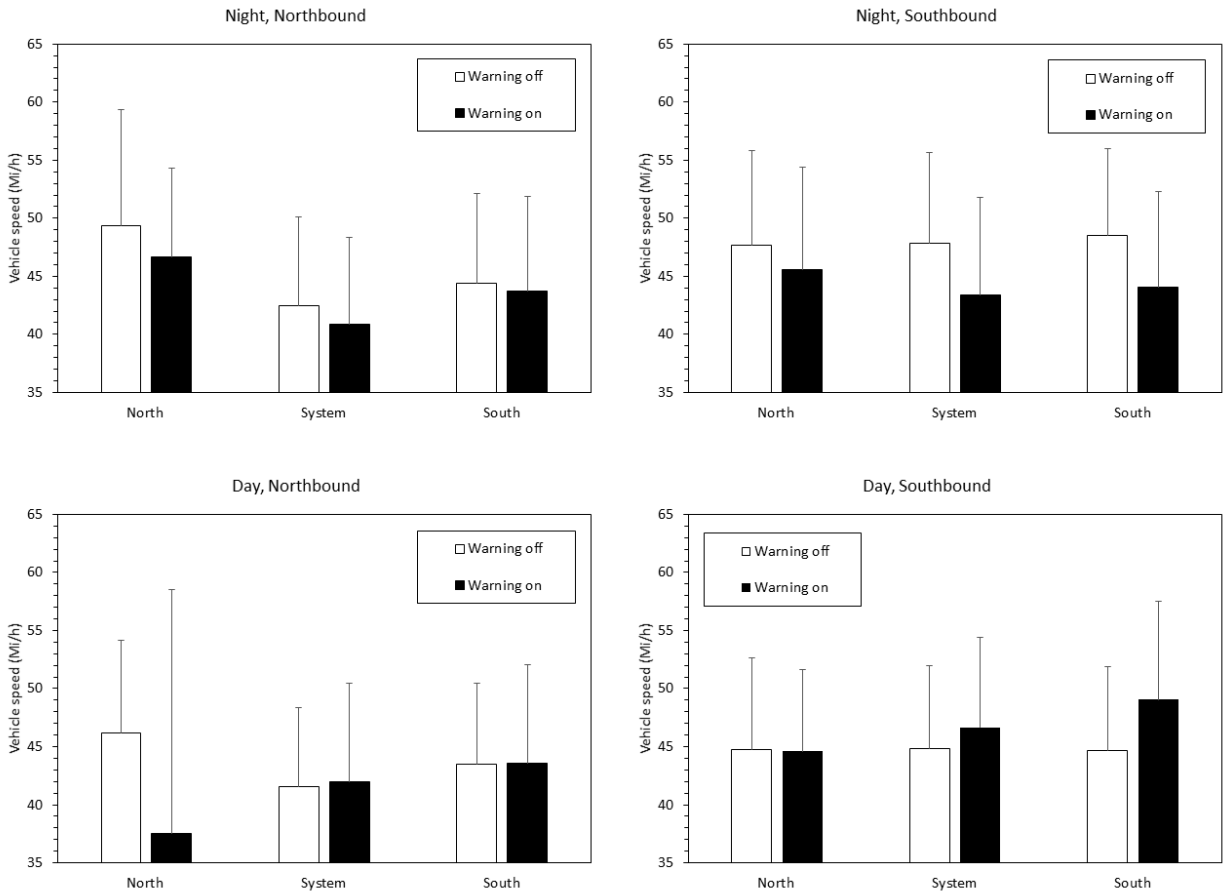
The average vehicle speed in winter was calculated and broken down by treatment (warning signs off vs. warning signs on), light conditions (day vs. night), and for travel direction (northbound vs. southbound) (Figure 24).

Note: The data relate to warning signs off and warning signs on, during day and night, and for northbound and southbound traffic.

**Figure 24. Average Vehicle Speed and Associated Standard Deviation in Winter.**

In winter, travel direction (northbound vs. southbound) had a significant effect on vehicle speed at the location of the system (main effect) (Tables 16, 17). The effect of treatment (warning signs off vs. warning signs on) on vehicle speed was also significant, but the effect depended on the light conditions (day vs. night) (Tables 16, 17). At night, vehicle speed was 3.01 mi/h lower with the warning signs on than with warning signs off. During the day, vehicle speed was 1.08 higher with warning signs on than with warning signs off (Table 17). The effect of treatment (warning signs off vs. warning signs on) on vehicle speed was also significant in interaction with travel direction (northbound vs. southbound) and light conditions (day vs. night) (Table 16). During the night, vehicle speed was lower (1.59 mi/h for northbound traffic, 4.43 mi/h for southbound traffic) with warning signs on than with warning signs off

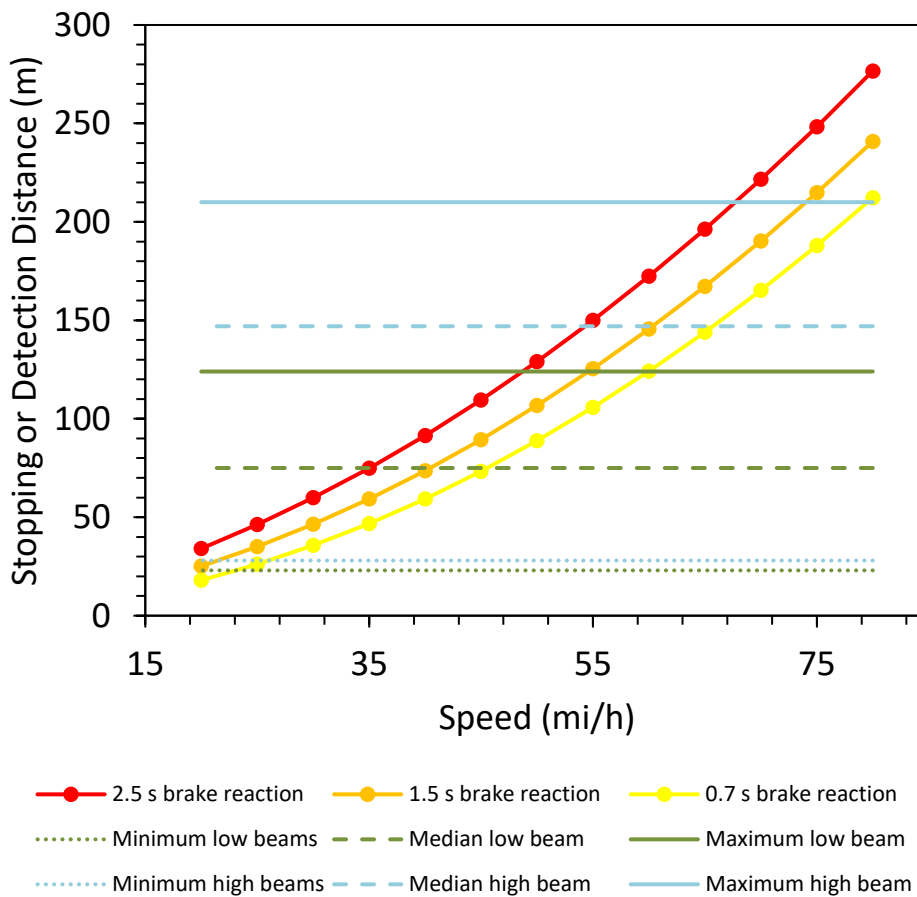
The stopping distance depends on brake reaction time as well as vehicle speed (Figure 25). For drivers to be able to stop in time in their travel lane for a large mammal that does not move out of that travel lane, they must have a stopping distance that is shorter than the distance at which they detect the animal (Figure 25).

Figure 25. Stopping Distances and Detection Distances for Large Mammals

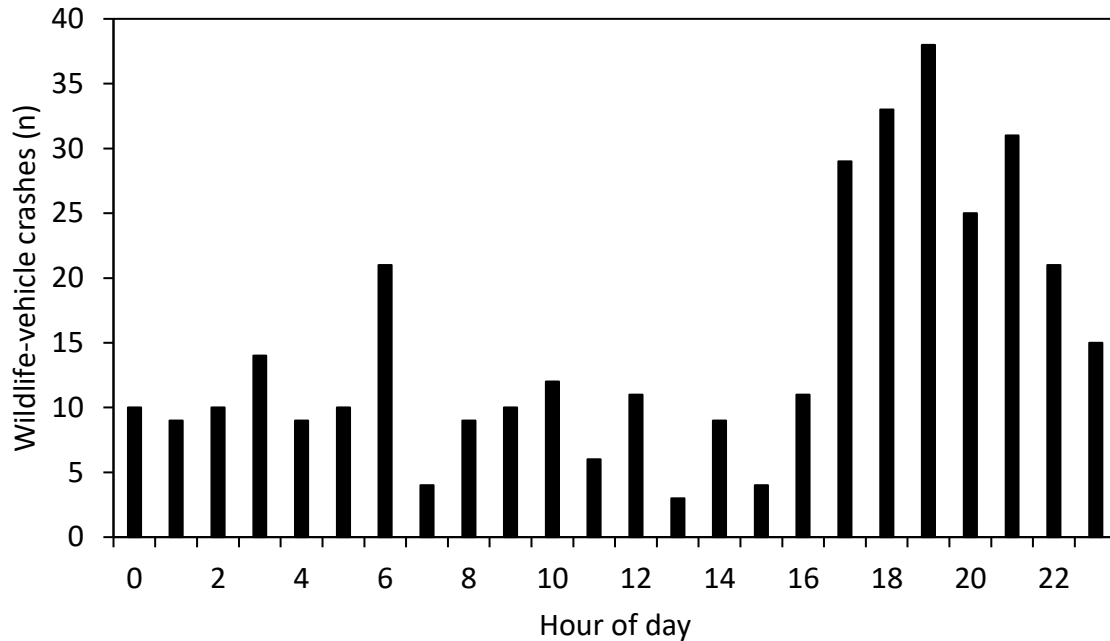
Most wildlife-vehicle crashes occurred in the late afternoon until midnight (Figure 26). A smaller peak in crashes occurred in the early morning. Most crashes (74.01 percent) occurred during the night, only 25.99 percent occurred during the day.

Note: The data relate to U.S. Hwy 95 (between mile reference posts 510 and 538).

**Figure 26. The Distribution of Wildlife-Vehicle Crashes over the Hours of the Day.**
