# NCHRP 25-25, Task 113

## ROAD PASSAGES AND BARRIERS FOR SMALL TERRESTRIAL WILDLIFE SPECIES

### CASE STUDIES 3 & 4, DRAINAGE CULVERTS

### CASE STUDY 3: USE OF SHELVING IN DRAINAGE CULVERTS FOR SMALL MAMMALS

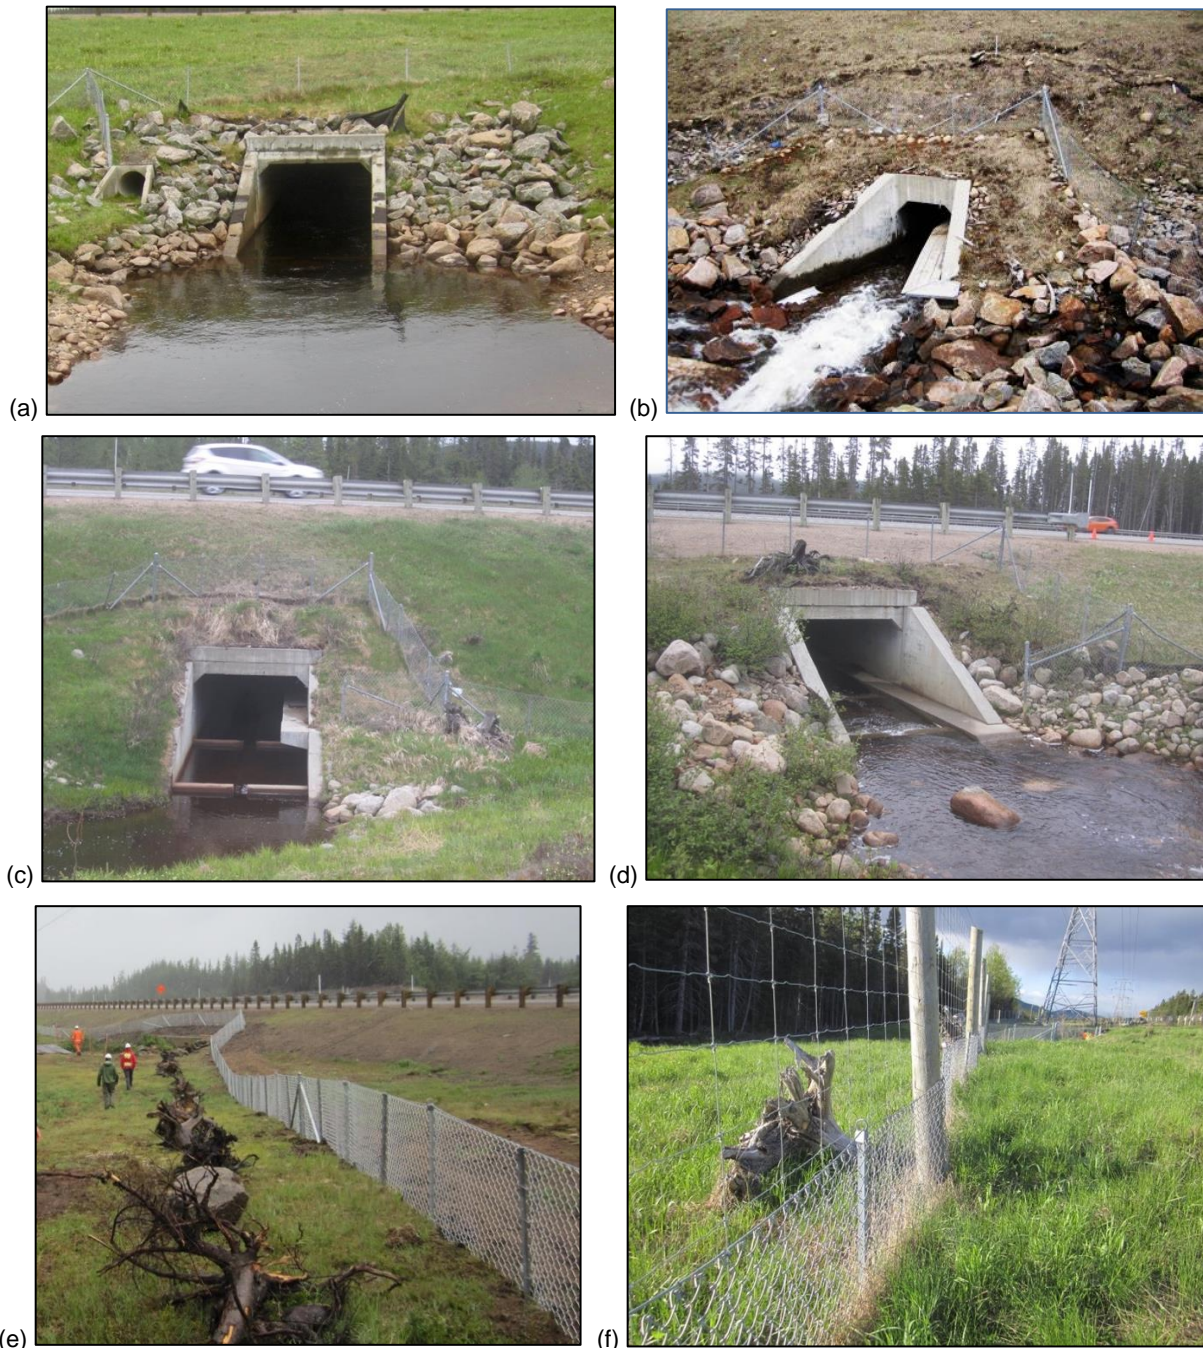
**Figure 3:** The four types of wildlife underpasses designed for small and medium-sized mammals and the two types of fences along Highway 175: (a) pipe culvert or round concrete culvert (on the left next to the water culvert;  $n = 6$ ), (b) box culvert with a wooden ledge ( $n = 4$ ), (c) box culvert with a concrete ledge ( $n = 7$ ), (d) box culvert with a concrete walkway ( $n = 1$ ), (e) fence for medium-sized mammals, and (f) combined fencing for large mammals (upper half) and medium-sized mammals (lower half). Photo Credit: Concordia University Montreal, J. Jaeger.

- Diameter of adjacent pipe culvert without shelving: 60 centimeters (cm) and 90 cm (Figure 3a)
- Minimum width and height of box culverts: 1.2 m (Figures 3a-3d)
- Maximum width and height of box culverts: 1.5 m (Figures 3a-3d)
- Range of length of all box and pipe culvert: 46 to 91 m (Figures 3a-3d)
- Concrete ledge width: 0.49 m (Figure 3c); wood ledge width: 0.54 m (Figure 3b); 0.69 m distance of ledge from ceiling

**Barrier Type and Dimensions (Figure 3e):** Each fence was about 100 m long in each direction from the small animal underpass.

- Chain link
- 90 cm high with a 6 cm mesh size.

- American marten, fisher, Canada lynx, and northern flying squirrels were not detected at the culverts
- Used by more than 17 species, primarily marmots (*Marmota monax*)
- Most mammal species used concrete pipe culverts (Figure 3a)
- Wooden ledge culverts were preferred over concrete ledge culverts
- Pipe culverts (Figure 3a) were discovered more by micromammals, e.g., shrews and voles
- Wooden ledge box culverts were used more by red squirrels
- Mammals preferred single segment structures with no open medians

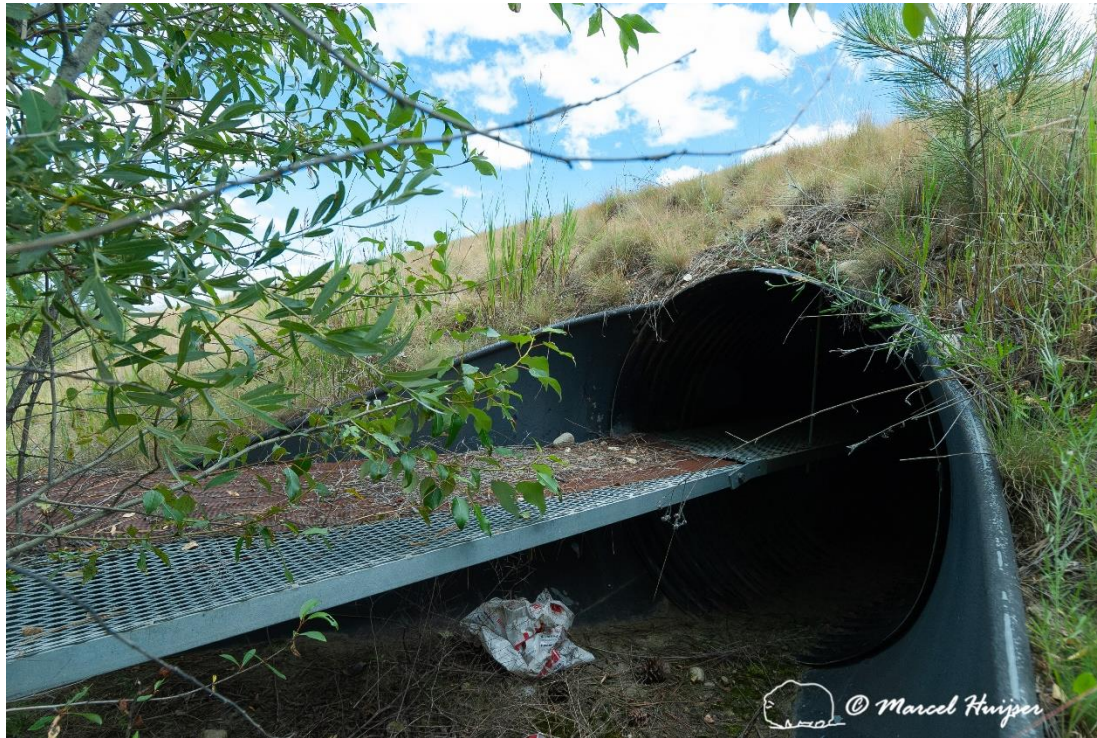
**Figure 4:** Metal shelving installed in drainage culvert in Montana.

**Alternate Designs:** Other research has studied the use of ledges in drainage culverts for small to medium-sized mammals. These include catwalks in drainage culverts for bobcats (Cain et al. 2003). Another study documented successful use of custom-built wood ledges that were added to various box and round drainage culverts, some with and some without entrance ramps, for the Preble's meadow jumping mouse (*Zapus hudsonius preblei*) (Meaney et al. 2007; CO-7, Repository). Foresman (2004) added flat galvanized expanded metal mesh (6-millimeter [mm]) shelving to round drainage culverts in Montana and studies use when waters rose. In addition, tubes made from plastic rain gutters were also used by voles (Figures 4 and 5).

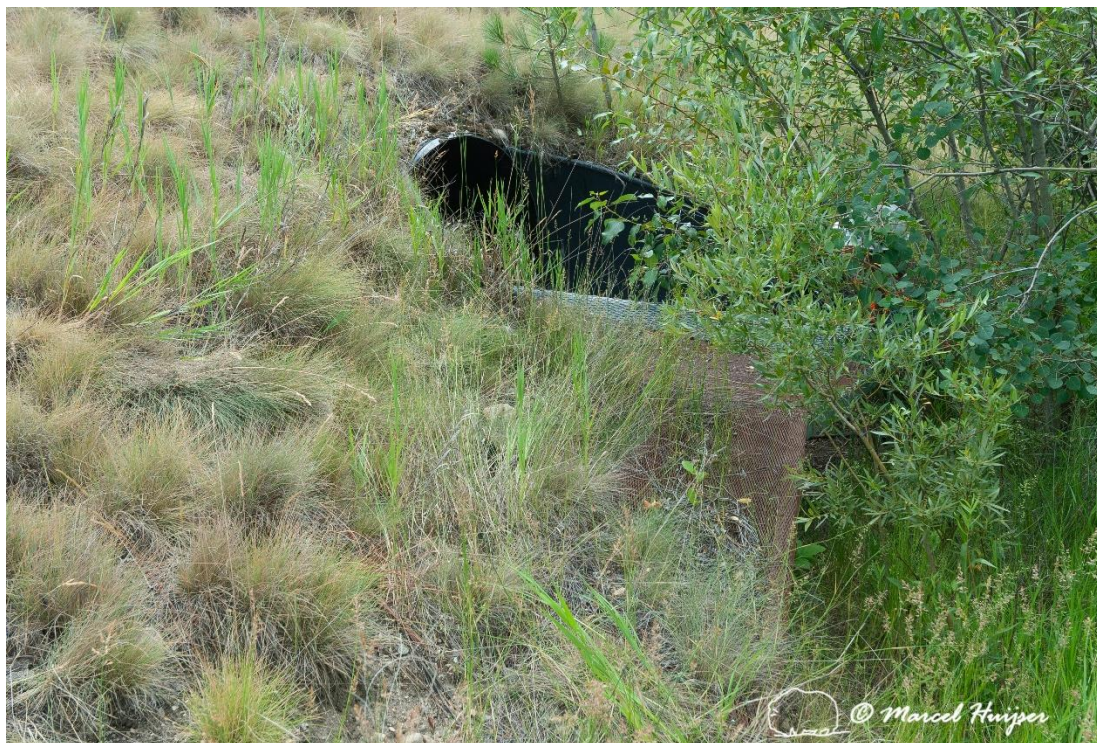
**Figure 5:** Ramp extending at right angle from metal shelving installed in a drainage culvert in Montana.

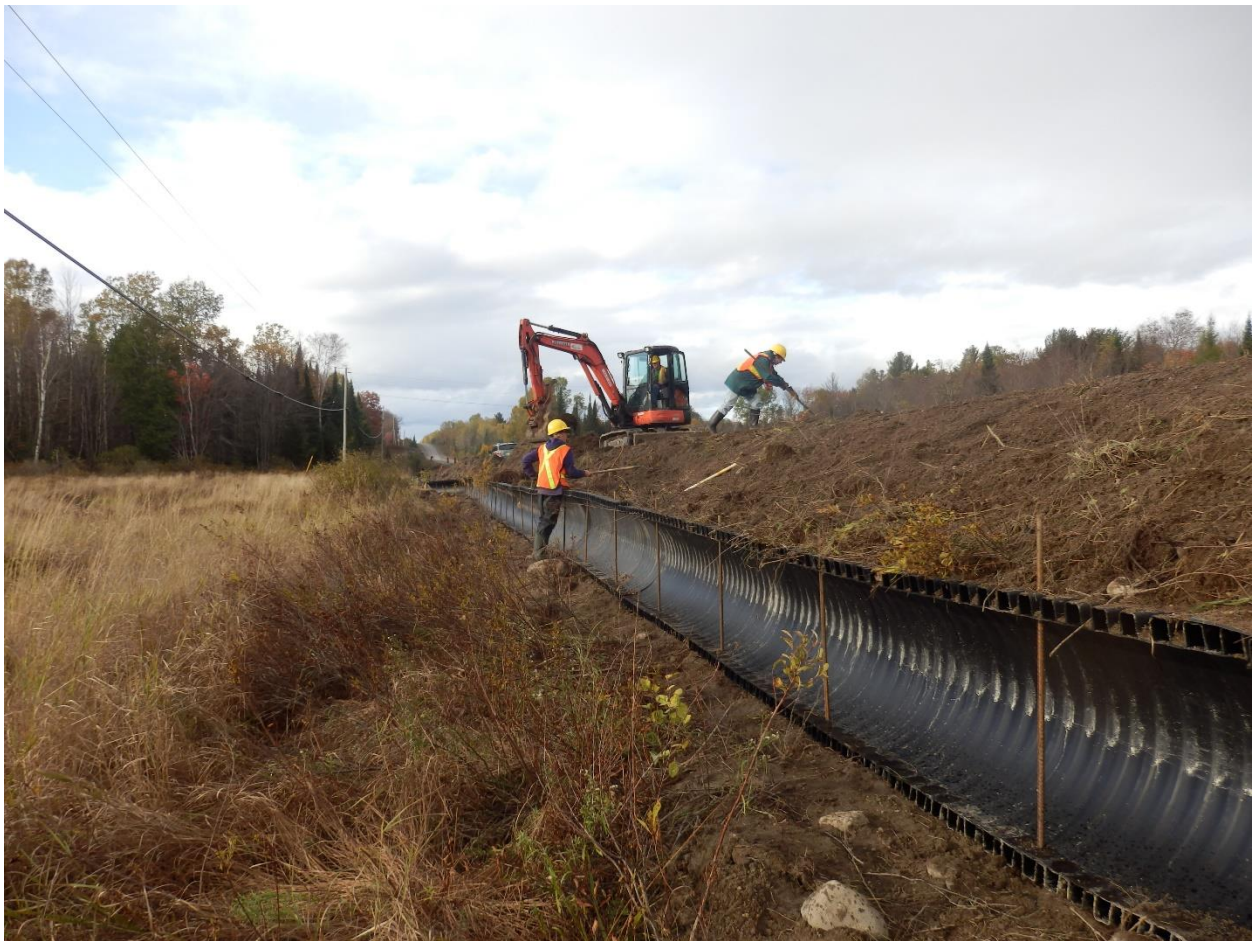
**Figure 6:** Boss HDPE materials used for barrier wall with back-fill and supported with steel rods. Photo Credit: Paul Heaven.

#### **Barrier Type and Dimensions (Figure 6):**

- Used readily available and inexpensive materials to construct the barrier wall; BOSS 2000 HDPE culvert pipe cut in half lengthwise, 75 cm diameter
- Held upright with 1.9 cm steel rod of 150 cm and 200 cm lengths
- Buried to a depth of 15 cm
- Height aboveground 60 cm
- Backfill from buried excavation used on-top of the backside of the fence and seeded so vegetation would hold the soil in place

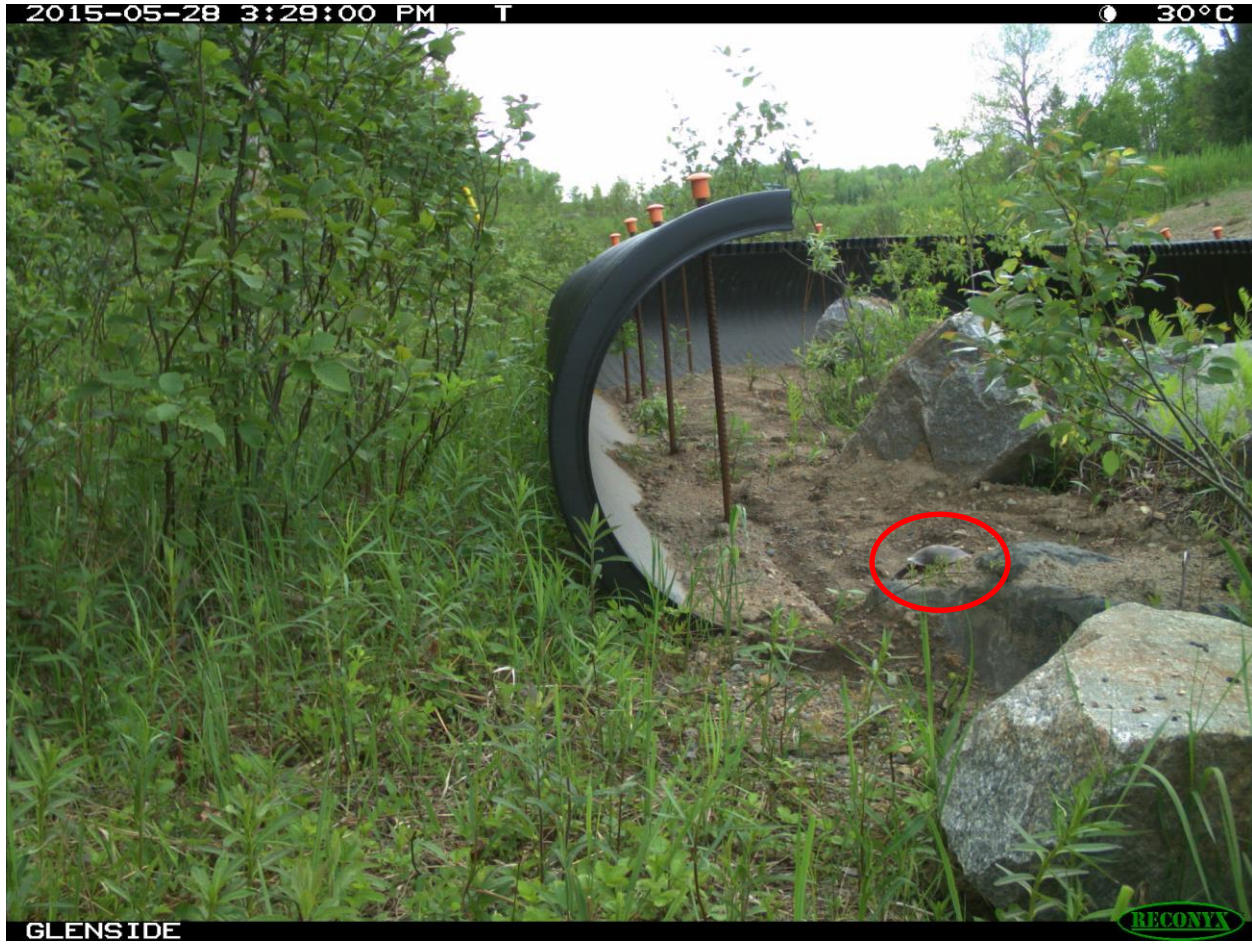
**Figure 7:** Curved back barrier ends that redirected at least 23% of the turtles back towards the drainage culvert; turtle shown in red circle. Photo Credit: Paul Heaven.

**Fence-end Treatment (Figure 7):**

- Curved ends that ran back at an angle of 135 degrees for 6 m then ran parallel to the wall for another 6 m

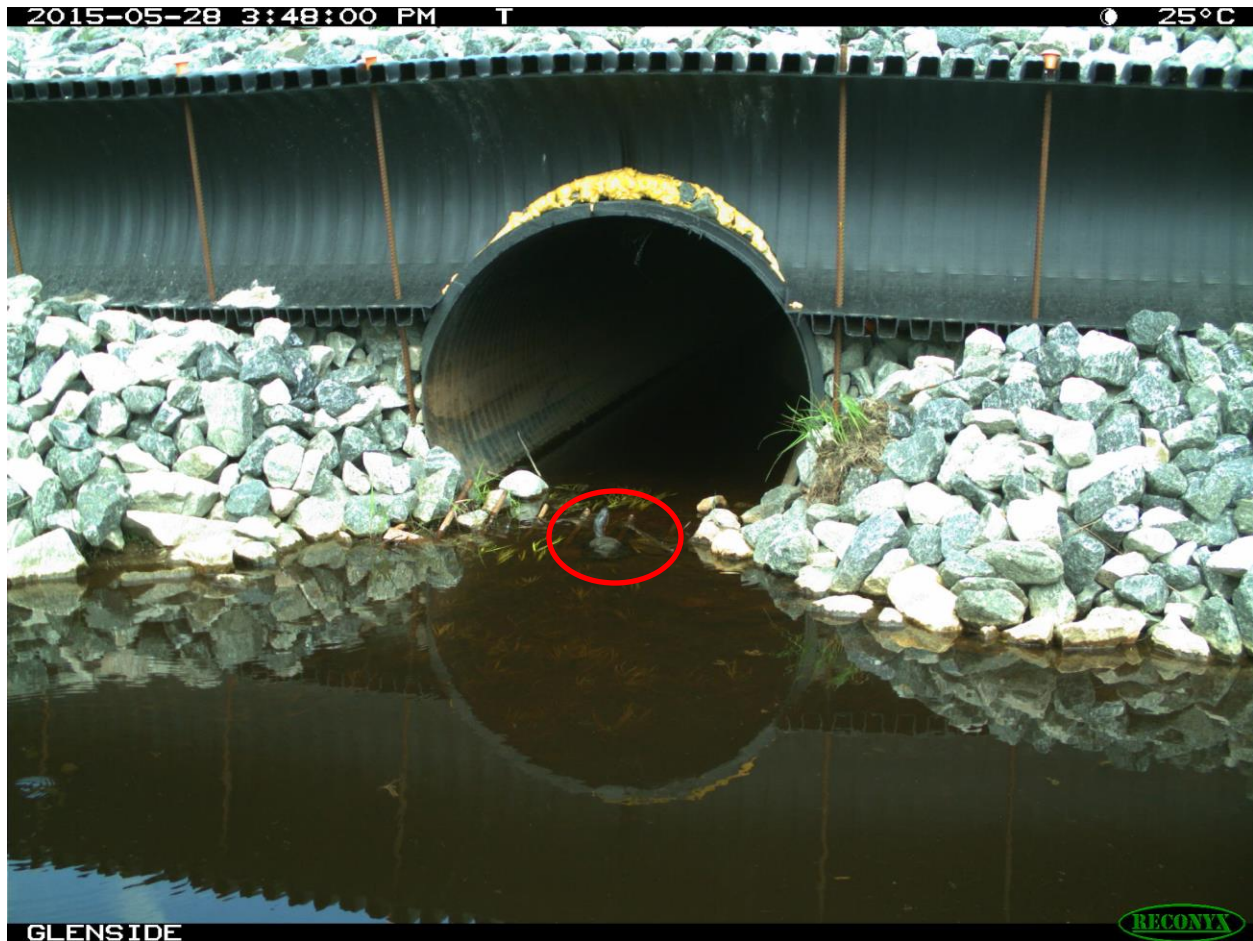
**Figure 8:** *Blanding's Turtle entering the 1.2-m drainage culvert shown in red circle. Photo Credit: Paul Heaven.*

**Effectiveness in Providing Connectivity:** Monitoring occurred over a 3-year period: 2014 (Before); and 2015 and 2016 (After). Cameras were used at each end of the culvert and at the four fence-ends. Cameras were set to capture animals at 1-minute intervals between 5:00 am and 9:00 pm daily from May to June in 2015 and 2016. There were 371 observations of turtles near the culverts—4 Blanding’s turtles (Figure 8), 42 snapping turtles, and 14 painted turtles were observed completely crossing the culvert.
